Assessing the Performance of Concrete Mixed with Different Water Sources within Small Scale Mining Catchment Areas in Ghana

Original Research Article

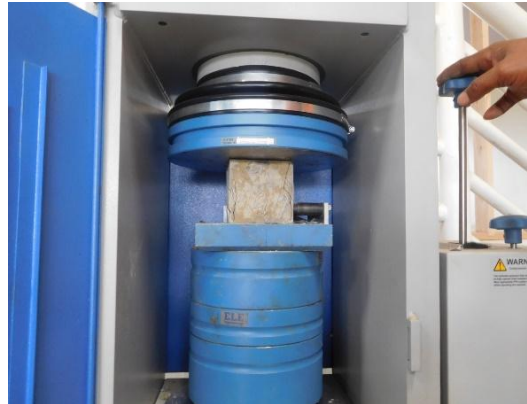
Fig. 1. Compressive strength test setup

The test was conducted in accordance with BS EN 12390-3 [23] on cubes at the 7th and 28th days curing. A compressive testing machine (Fig. 1) was used for the testing. An incremental load was applied at a loading rate of 5 kN/s (5 mm/min) to every cube until failure and the maximum compressive stress recorded.

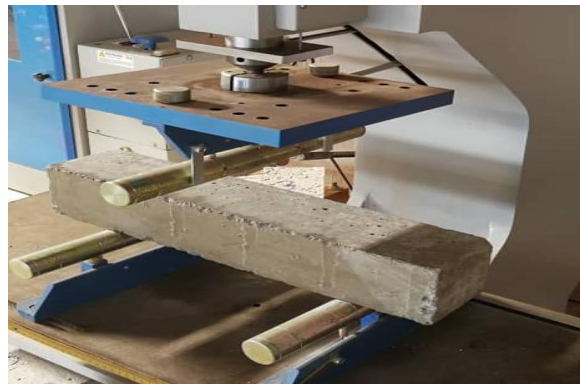
Fig. 2. Concrete beam under flexural strength test

The flexural strength test was conducted using a digital flexural strength testing machine manufactured by Controls Milano, Italy, as shown in Fig. 2. With a central point loading setup, the beam was subjected to incremental loading at a loading rate of 0.20 kN/s until failure, in accordance with BS EN 12390-5 [24]. The maximum tensile stress was recorded.

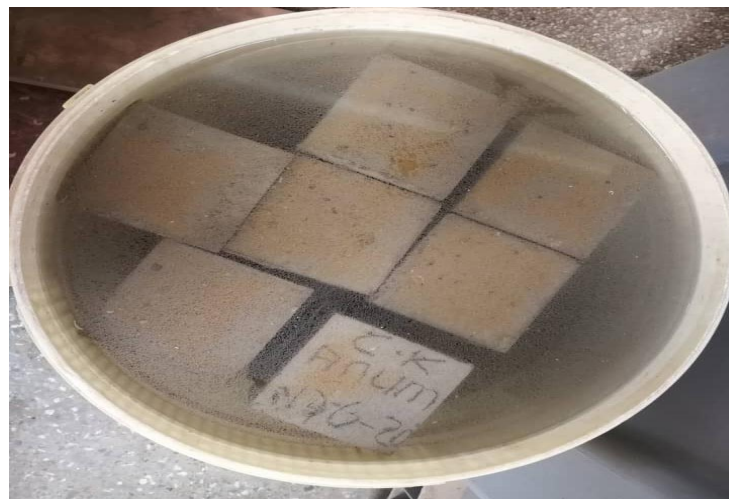
Fig. 3. Cubes in MgSO₄ solution

The sulphate attack test was conducted by immersing concrete specimens after the 28th day curing in water as shown in Fig. 3. The test followed ASTM C1012 [25]. The test was conducted in a laboratory with a relative humidity of 80% and temperature of 23°C ± 5°C. The concrete specimens were further cured in a water tank containing 5% magnesium sulphate for 28, 56, 90 and 180 days. The pH level of the sulphate solution was monitored. The sulphate solution was replaced whenever the pH value exceeded 9.5. The degree of sulphate attack was

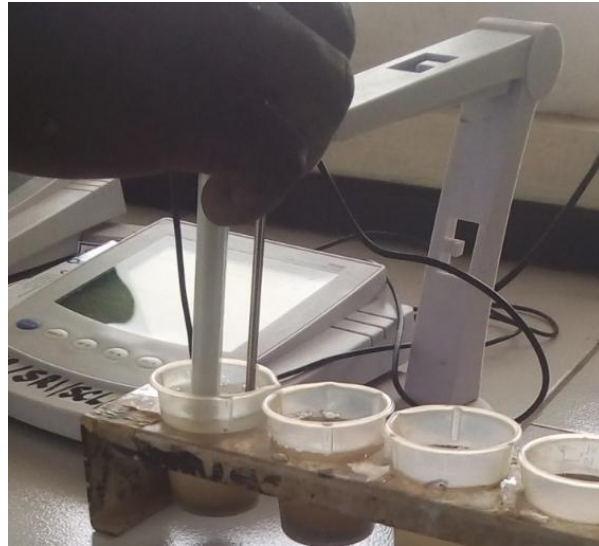
Fig. 4. Measure of alkalinity

Tests were carried out on specimens at the 28th day of water curing. The pieces of tested specimens were again broken into small pieces using a hammer and a ball mill and then powdered. Twenty grams of each of the powdered samples, was put into 100 ml distilled water (Fig. 4). The aqueous solution was allowed

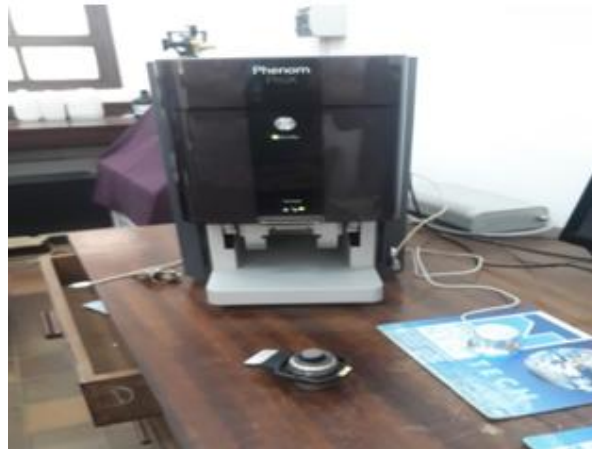
Fig. 5. SEM/ EDX set Up

Phenom Prox S-3400N Scanning electron microscope (SEM) was used to take images of the concrete samples as shown in Fig. 5. A concrete prism after curing for 28 days was cut into cubes of size 10mm. The specimen was subjected to gold sputtering to make it conductive. The testing procedures were performed according to ISO/TS 24597 [26].

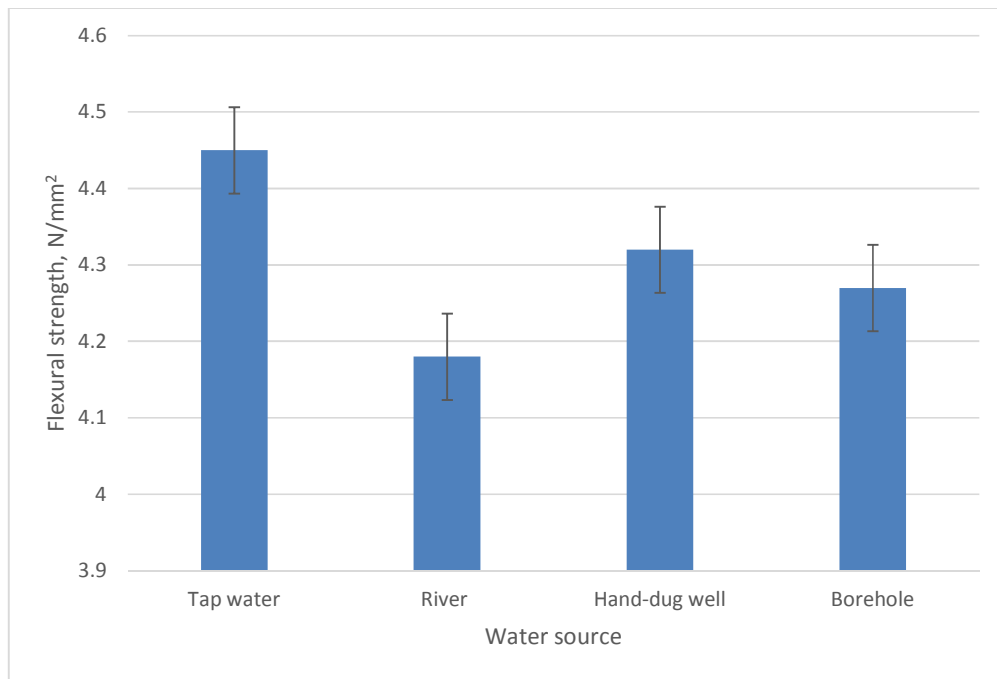
Fig. 6. Flexural strength of concrete specimens after 28th day curing

Fig. 6 illustrates the results of the flexural strength of the concrete specimens. The results

followed the pattern of the compressive strength results. The beam cast with tap water recorded the highest strength value of 4.46 N/mm^2 whereas that of the borehole recorded the least strength value of 4.18 N/mm^2 . The flexural strength values of specimens mixed with water from the rivers and hand-dug well were 4.32 N/mm^2 and 4.27 N/mm^2 respectively. In comparing the two strengths (compressive and flexural), there exists a relationship between the two; hence the same factors that influenced the variations in compressive strength could be said to have also influenced the flexural strength.

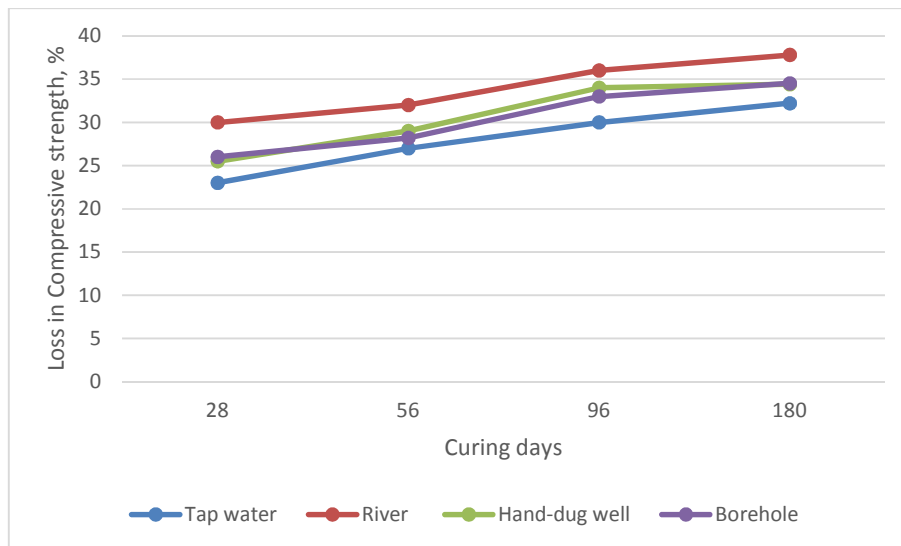
Fig. 7. Loss in compressive strength after immersion in MgSo₄

Results from Fig. 7 indicate the loss of compressive strength of concrete after 28 days' immersion in 5% of magnesium sulphate (MgSO_4). The compressive strength loss was 23%, 26%, 25.5% and 30% for concrete mixed and cured with water from tap, bore hole, hand dug well and river respectively. After 180 days of immersion in MgSO_4 solution, the concrete with water from the tap, borehole, hand-dug well and river lost about 32%, 35%, 34% and 38% respectively of their compressive strength. The loss of compressive strength was highest in the concrete mixed with water from the rivers. This could be ascribed to the higher presence of TSS and TDS which might have been dissolved by the MgSO_4 solution leaving voids in the concrete, hence the higher loss of compressive strength.

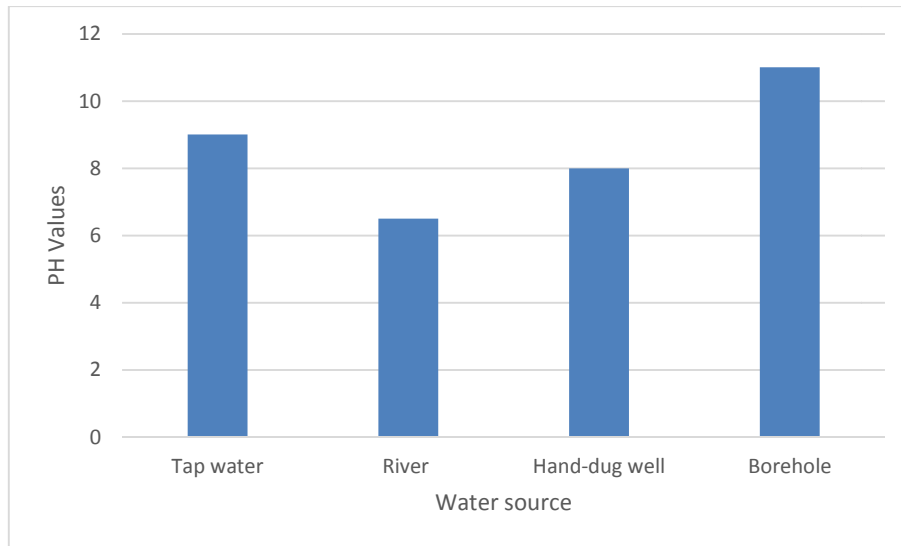
Fig. 8. Measure of alkalinity (PH value) of concrete samples

The results of the pH values of the concrete samples as shown in Fig. 8 indicated that the concrete samples mixed with tap water and borehole were alkaline with PH values of 9 and 11 respectively. On the other hand, concrete samples mixed with the rivers and hand dug wells had pH values 6.5 and 8 respectively, which fell below the range of alkalinity of between 9 and 12. The alkalinity in the concrete specimens mixed with water from the rivers and hand dug wells was not adequately high enough to protect the steel reinforcement bars from corrosion.

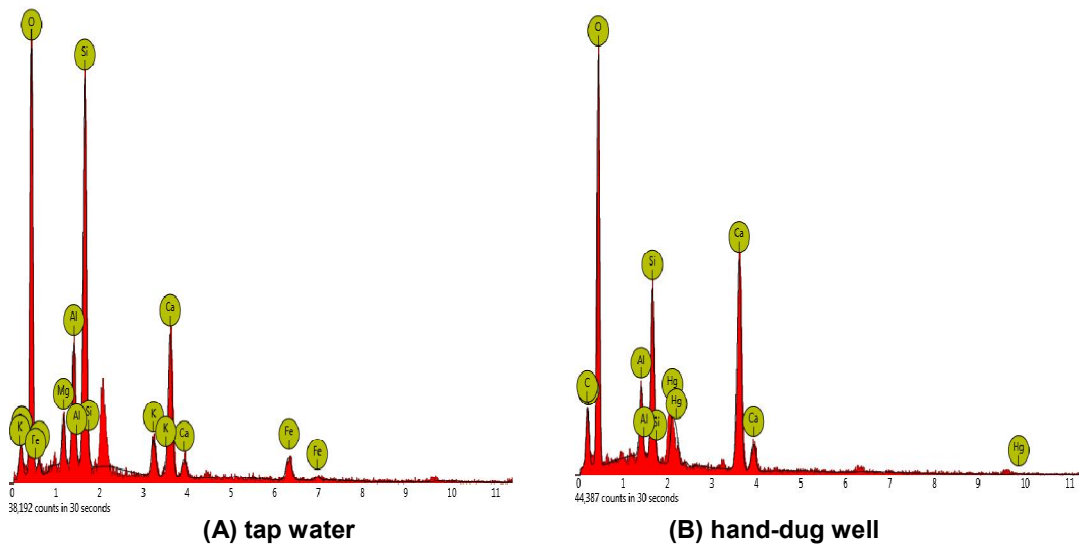
Fig. 9. EDS images of chemicals in concrete sample (A = tap water, B = hand-dug well, C = borehole, D = River)

The concrete samples prepared with water from tap, hand dug well, borehole and river had the weight concentration of mercury values of about 2.47kg, 96kg, 65kg and 99kg respectively. The specimens made from the river and the hand-dug well showed heavy presence of mercury in the concrete sample as indicated in Table 6 and demonstrated by the EDS images in Fig. 9.

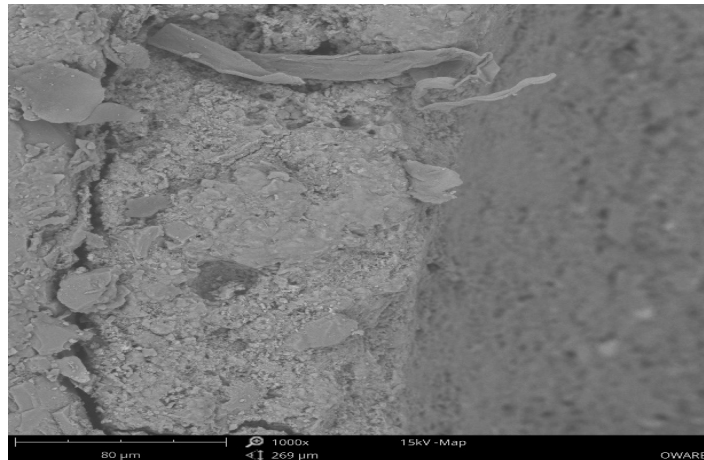
Fig. 10. SEM images of concrete samples from water sources (a) tap water (b) borehole (c) had-dug well (d) river

SEM images from the analyses revealed deep cracks at several spots throughout the river and hand dug well concrete samples (Fig. 10). On the other hand, the tap water specimen had less cracks, and this could be due to less chemical impurities as the EDS analysis revealed. One major function of water in concrete is to wet the surface of aggregates to develop adhesion because the cement paste adheres to aggregates. However, the presence of chemical impurities in the river, used during the concrete mix, could reduce its adhesive abilities and thereby reduce the strength of the concrete as indicated earlier in Table 2. Chemical impurities

had the tendency of causing chemical reactions within the concrete mix and could therefore affect the bonding strength of the mixture, hence reducing the strengths of the concrete samples mixed with contaminated water from the “galamsey” areas (Olugbenga, 2014). The presence of cracks in concrete adversely affects the strength of the concrete. This could be due to the fact that the cracks served as conduits for fluid transportation which might have facilitated chemical reactivity within the concrete and subsequently led to reduction of the strength of the concrete samples mixed with water from the “galamsey” areas.
